The clutch of big-block Guzzis: No more heat warping of the intermediate plate – modification.

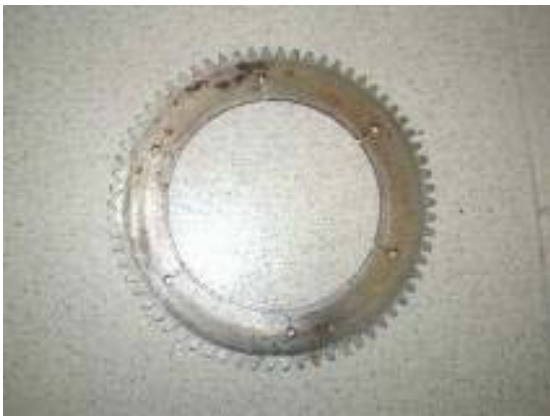
Figure 1 (photo: Georg)

Some owners of big-block Guzzis have experienced heat warping of the clutch intermediate plate, thereby causing malfunction of the clutch. This applies in particular to bikes used with a sidecar or otherwise working under heavy load conditions where the build-up of heat in the clutch can be severe. It appears the plate warps by taking on a 'conical' shape instead of remaining 'flat'.

The purpose of the holes is merely to create a clean finish of the incisions and thereby prevent initiation of further crack developments, but this detail is surely very important! The plate will now stay flat because the incisions will 'absorb' the expansion as the plate heats up.

This modification will only work properly on a plate that has not yet been damaged, preferably a new one. Do as follows: Drill 6 holes of 3 mm diameter evenly spread at the middle-radius of the plate (*fig.1*). Cut through the plate from the inner perimeter to each of the holes by use of e.g. a hacksaw. Dress the edges by the incisions (*fig.2*).
