How to identify the cylinder bores of roundfin Guzzis

Posted on the www.wildguzzi.com forum by Pete Roper on 12 November 2006.

This subject seems to have come up fairly regularly. I just so happen to have examples of all three in the w'shop at the moment so I've taken a few pics. All the shown barrels are essentially the same, they are all roundfins with an 83mm bore.

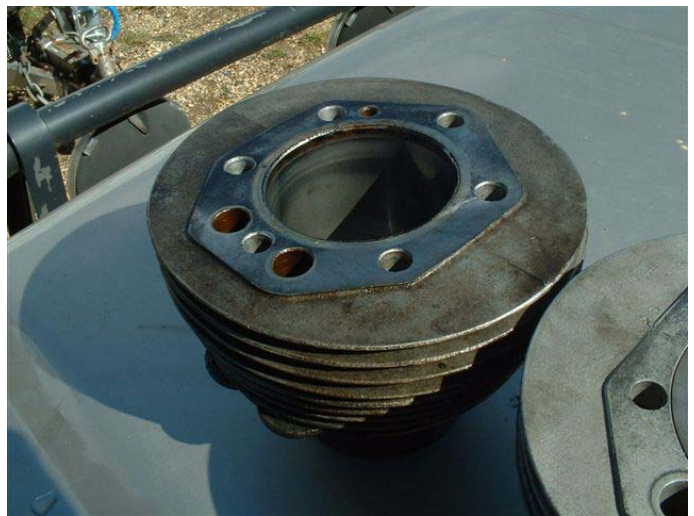
Pic 01:

This first one is a **chrome bore** off a T3.

Note the shiny in patches but ***mottled*** appearance. The mottling seems to be a precursor to peeling. After service they are generally shiny almost like show-chrome. When they flake the flakes expose the alloy underneath which wears rapidly leading to more peeling and eventually, (Soon.) broken rings. The lighter area on the top of the mating face is where the steel (?) insert of the kingerlite head gasket seats and seals the face betwixt head and barrel.

- Well, if they're **chrome** I bung 'em.
- **Cast iron** you can use hone-stones but a boron ball hone is best.
- **Nicasil** I never do anything with unless they look glazed (Only seen that a couple of times and I think it occurred because the owners were using a friction modified oil, not good in air cooled motors.)

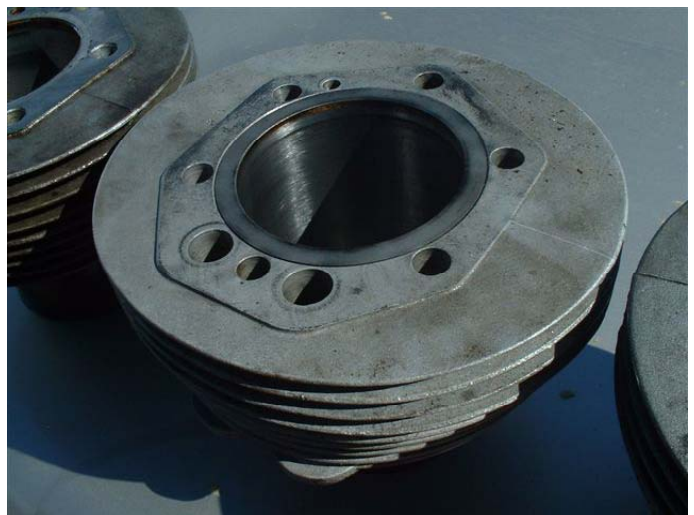
Pic 02:

This one shows a barrel with a **cast iron sleeve** off an Mk I LeMans.

As you can clearly see there is a well-defined difference between the alloy of the fin casting and the shrunken in cast iron sleeve. Note also that there are severe hone marks on the inside of the sleeve. This is one I'd honed in an attempt to get it to go around again with another set of rings. Unfortunately it wasn't to be. Also clearly visible in the top of the bore is the wear ridge formed where the top ring stops.

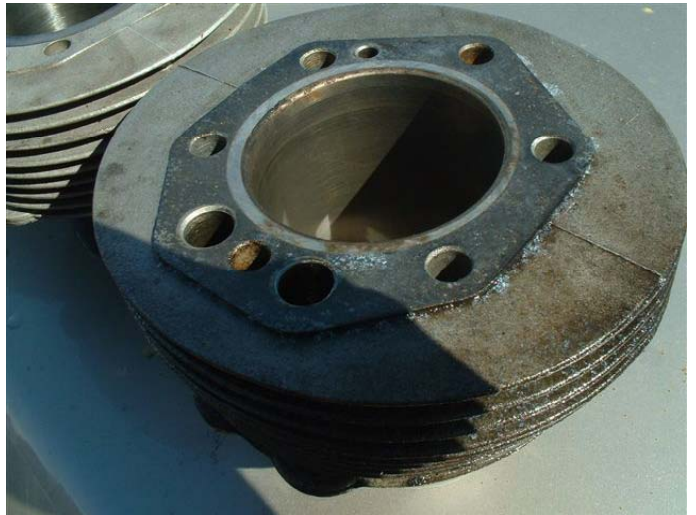
Pic 03:

This third barrel is a **Nicasil bore** off a late model Mk II LeMans.

Note the darker colour than the chrome but lack of the differentially coloured and clearly defined sleeve. While it is clearly obvious where the rings reach up to in the bore there is little or no *feelable* wear ridge and these particular barrels have done close to 100,000Km and are completely serviceable with a new set of rings.

Rings for standard pistons are plain cast iron and seem to bed in fine without treatment. If you look at the MkII barrel you can still see the original hone marks in the bore even at the sort of mileage that this bike had done. If they do look as if they need de-glazing I just give them a very light hone with hone stones but my theory is that this will do nothing more than disrupt an glazing and help prevent more forming. The other really nice thing about Nicasil is that it needs practically no care when running/breaking in by the time you've done 100 miles the rings should be seated and chances of seizure, (As long as they are gapped right.) are practically non existent.

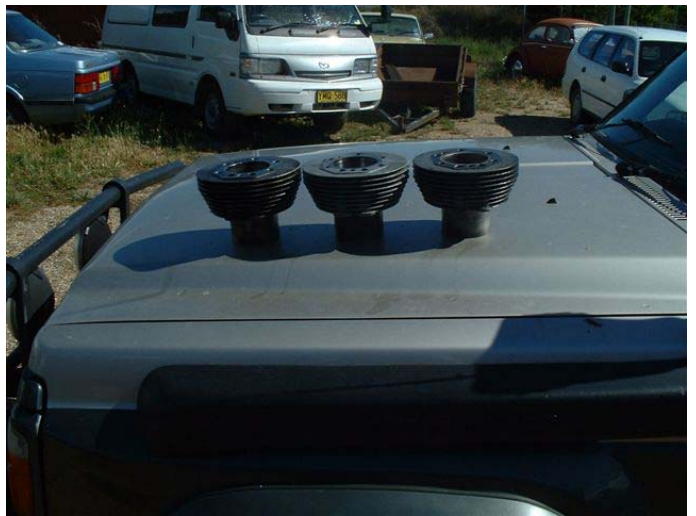
Pic 04:

At a glance they all look pretty much the same!

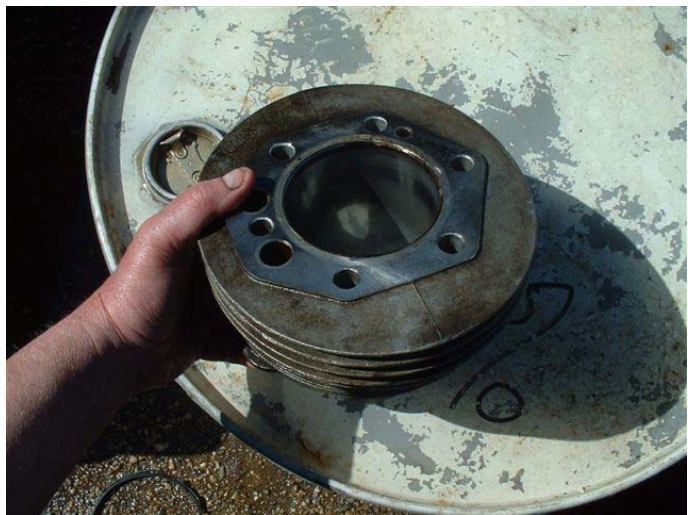
Pic 05:

Another shot down the throat of a **chrome bore**. In this you can better see the *Shinyness* of the chrome, it's almost mirror like in places and is not in the slightest way magnetic, you can check with a magnet.

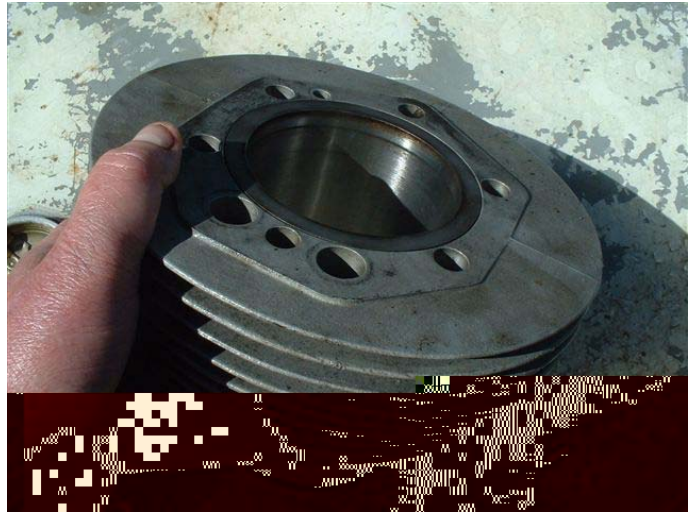
Pic 6:

The **cast iron bore**, once again showing the clearly defined wear ridge.

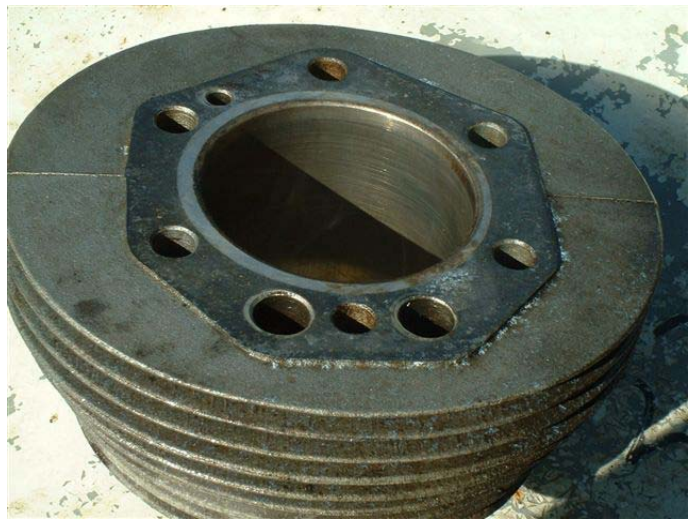
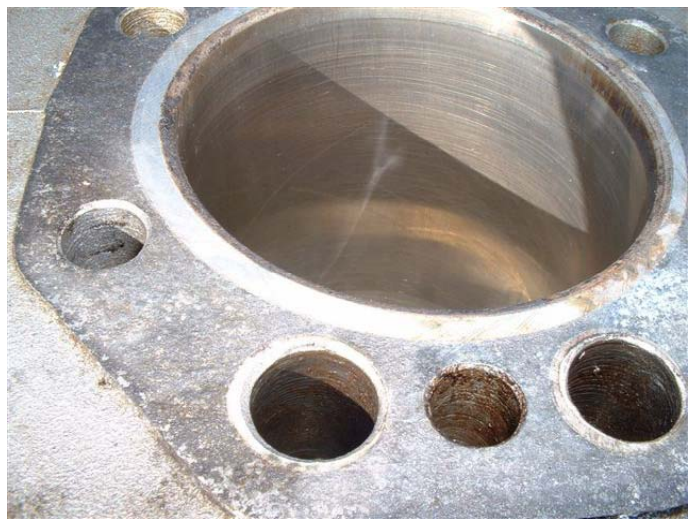
Pic 7 - 8:

Two more of the **Nicasil bore**. How sweet it is. Nicasil must have some component that is either ferrous or Tungstenite as it **is** mildly magnetic, unless it somehow absorbs ferrous deposits from the rings, (Shrug?) doubtfull.

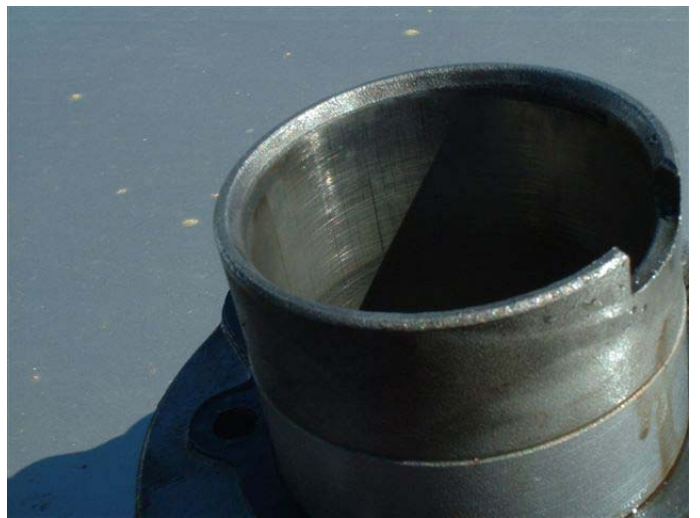
Pic 9:

Going the other way now this is the bottom of the **Nicasil cylinder** spigot. Note the *step* in the aluminium wall of the spigot, (The cutaway in the edge of the spigot is for the rod bolts to pass through as the crank spins incidentally.)

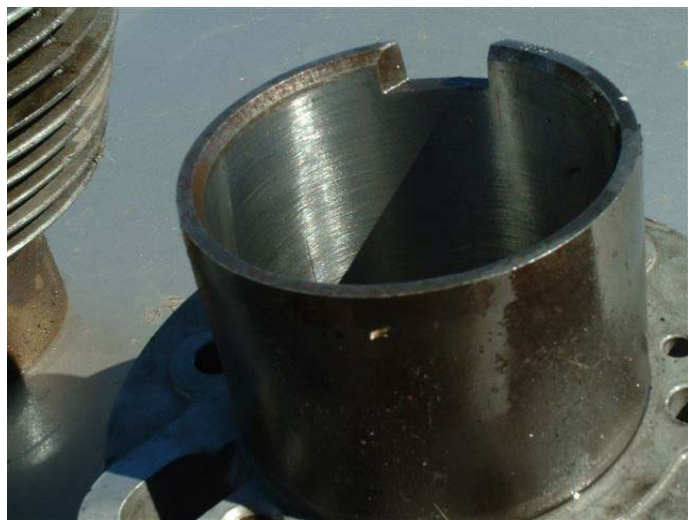
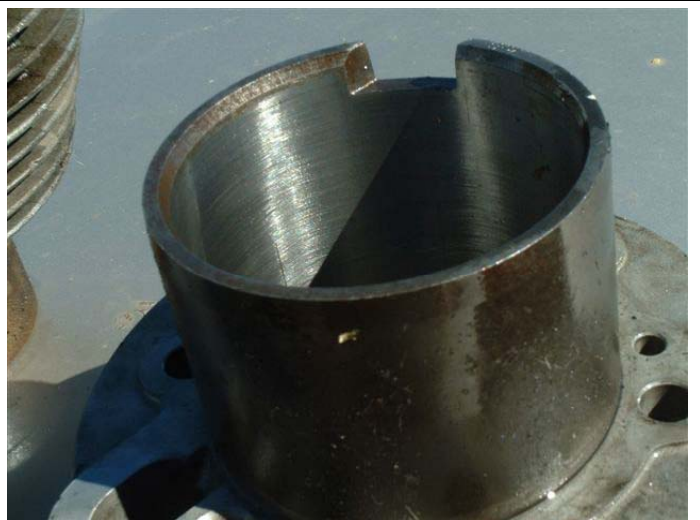
Pic 10 - 11:

Two of the spigot, (Actually the bottom of the sleeve of the **cast iron liner**.) of the Mk1 barrel, note the absence of the *shoulder* on the liner. The vertical streaks visible in the bore are the result of particulate contamination being dragged up and down the bore by the piston. Fit air filters!!!! Good ones!!!! Rings can't seal those scores!

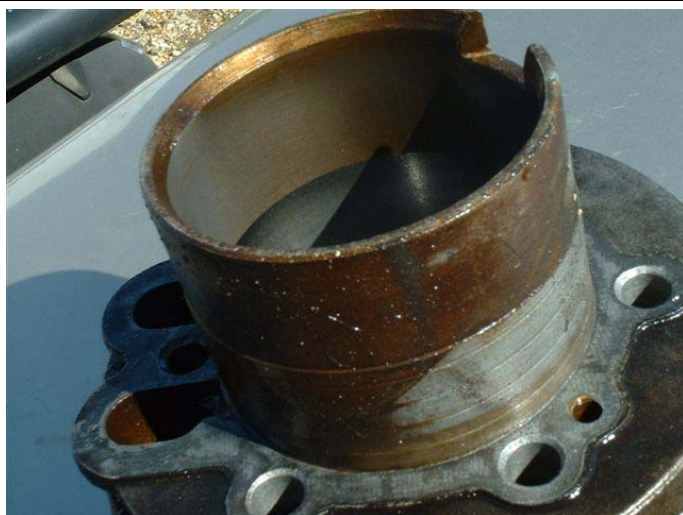
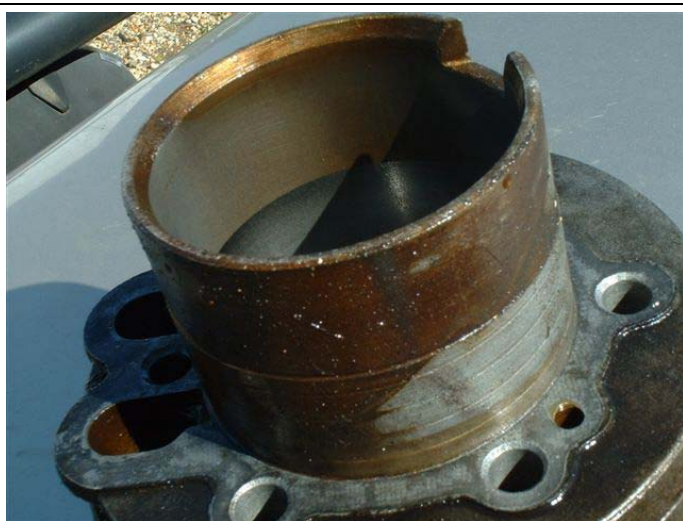
Pic 12 - 13:

Finally two of the **chrome bore** spigots. Note the seeming multiple steps in the spigot and most importantly the dull matt finish of the 'un-stroked' chrome.
