Replacing the Cheap POS Plastic Temp-Sensor Holder

Posted on the Guzzitech.com forum by Greg Field: June 19, 2006:

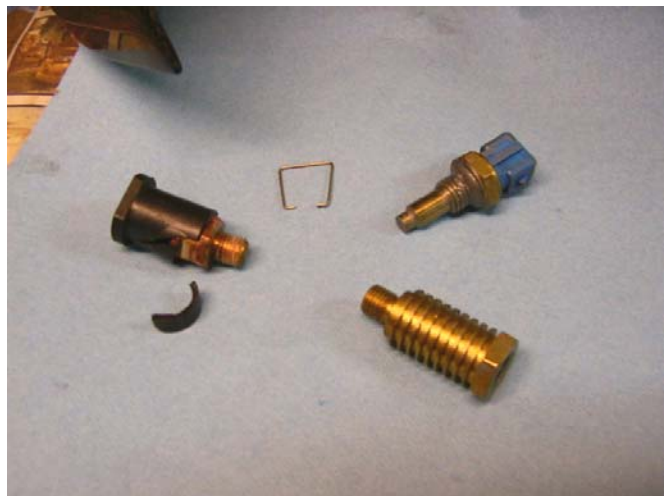
Pic 01:

So, I put a wrench on the holder and attempted to take it off the head. It just crumbled when I twisted the wrench. What a cheap POS!

This photo shows the crumbled plastic holder, the sensor, and the replacement brass holder.

Fortunately, I had the solid-brass replacement in waiting.

The next challenge was getting the metal base out of the head. Its hex portion was actually recessed into the head casting. To get it out, I had to grind the tip and side of a 15-mm deep-well socket. It was really in there, glued on with some type of loctite.

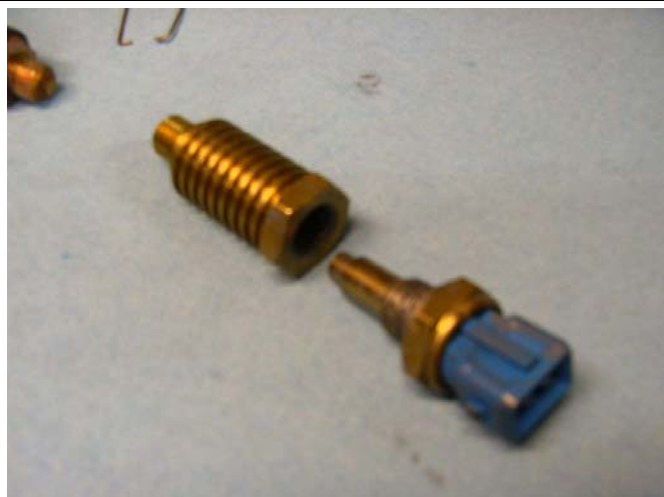
Pic 02:

Then, I did a trial fitting after smearing the sensor with anti-seize to leave witness marks as evidence that it had bottomed out in the holder. No surprise, it didn't bottom out, and there was no way to make it bottom out without a lot of milling work. Instead, I cheated, and filled the recess with anti-seize, which should do a good job of transferring heat between the holder and sensor.

It seemed to me that the system would work best if it transferred heat between the holder and sensor, without the holder radiating too much heat away from the sensor, so I decided to insulate the holder with several layer of duct tape, as shown in the next picture.
